*In a continuing effort to provide information to our users, here is the latest newsletter. Please let us know what we can do to improve it.*

#### New Management at MBWD

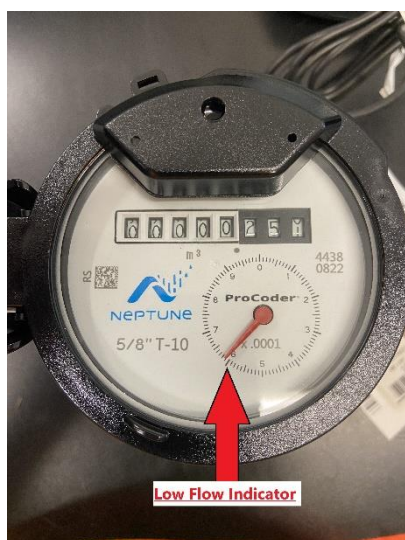
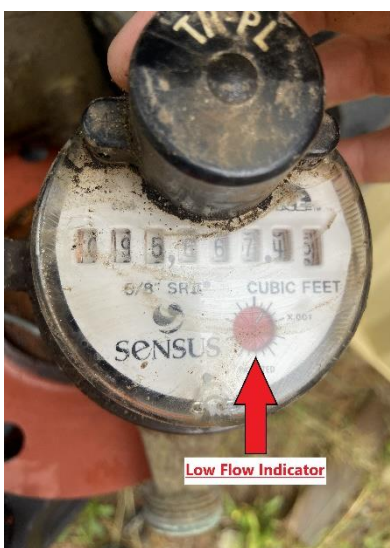
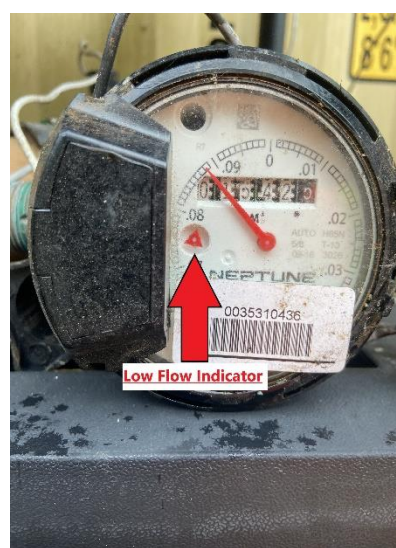
The water meter's installed by MBWD is the best leak detection device you can use. Below are illustrations of the three types of meters installed by MBWD.

- Ensure no water is running on the premises then check the water meter red flow indicator for turning/spinning. Any flow of water will be indicated.
- If the flow indicator is not spinning, there is no leak in your water system.
- If the flow indicator is spinning, there is a leak.
- If you have a shut-off valve in your home, which most homes have, shut it off. Now check the flow indicator again.
- If the flow indicator is still spinning, there's a leak between the meter and the house.
- If the flow indicator stops spinning, the leak is within the home and further troubleshooting should be considered.

- Ensure no water is running on the premises, then check the water meter to see if the low flow indicator is turning/spinning.
- If the low flow indicator is spinning, there is a leak present on the property, possibly from a toilet.
- If you have a shut-off valve in your home, which most homes have, shut it off. Now check the flow indicator again.
- If the low flow indicator is still turning/spinning, the leak is in between the meter box and the shut off valve at the house, possibly on an irrigation line.
- Irrigation valves can then be turned off one at a time if several are present, and the meter can be re-checked to narrow down the irrigation system leak location.
- If the low flow indicator stopped spinning when the shut off to the house was originally shut off, the leak is within the home possibly from a toilet.

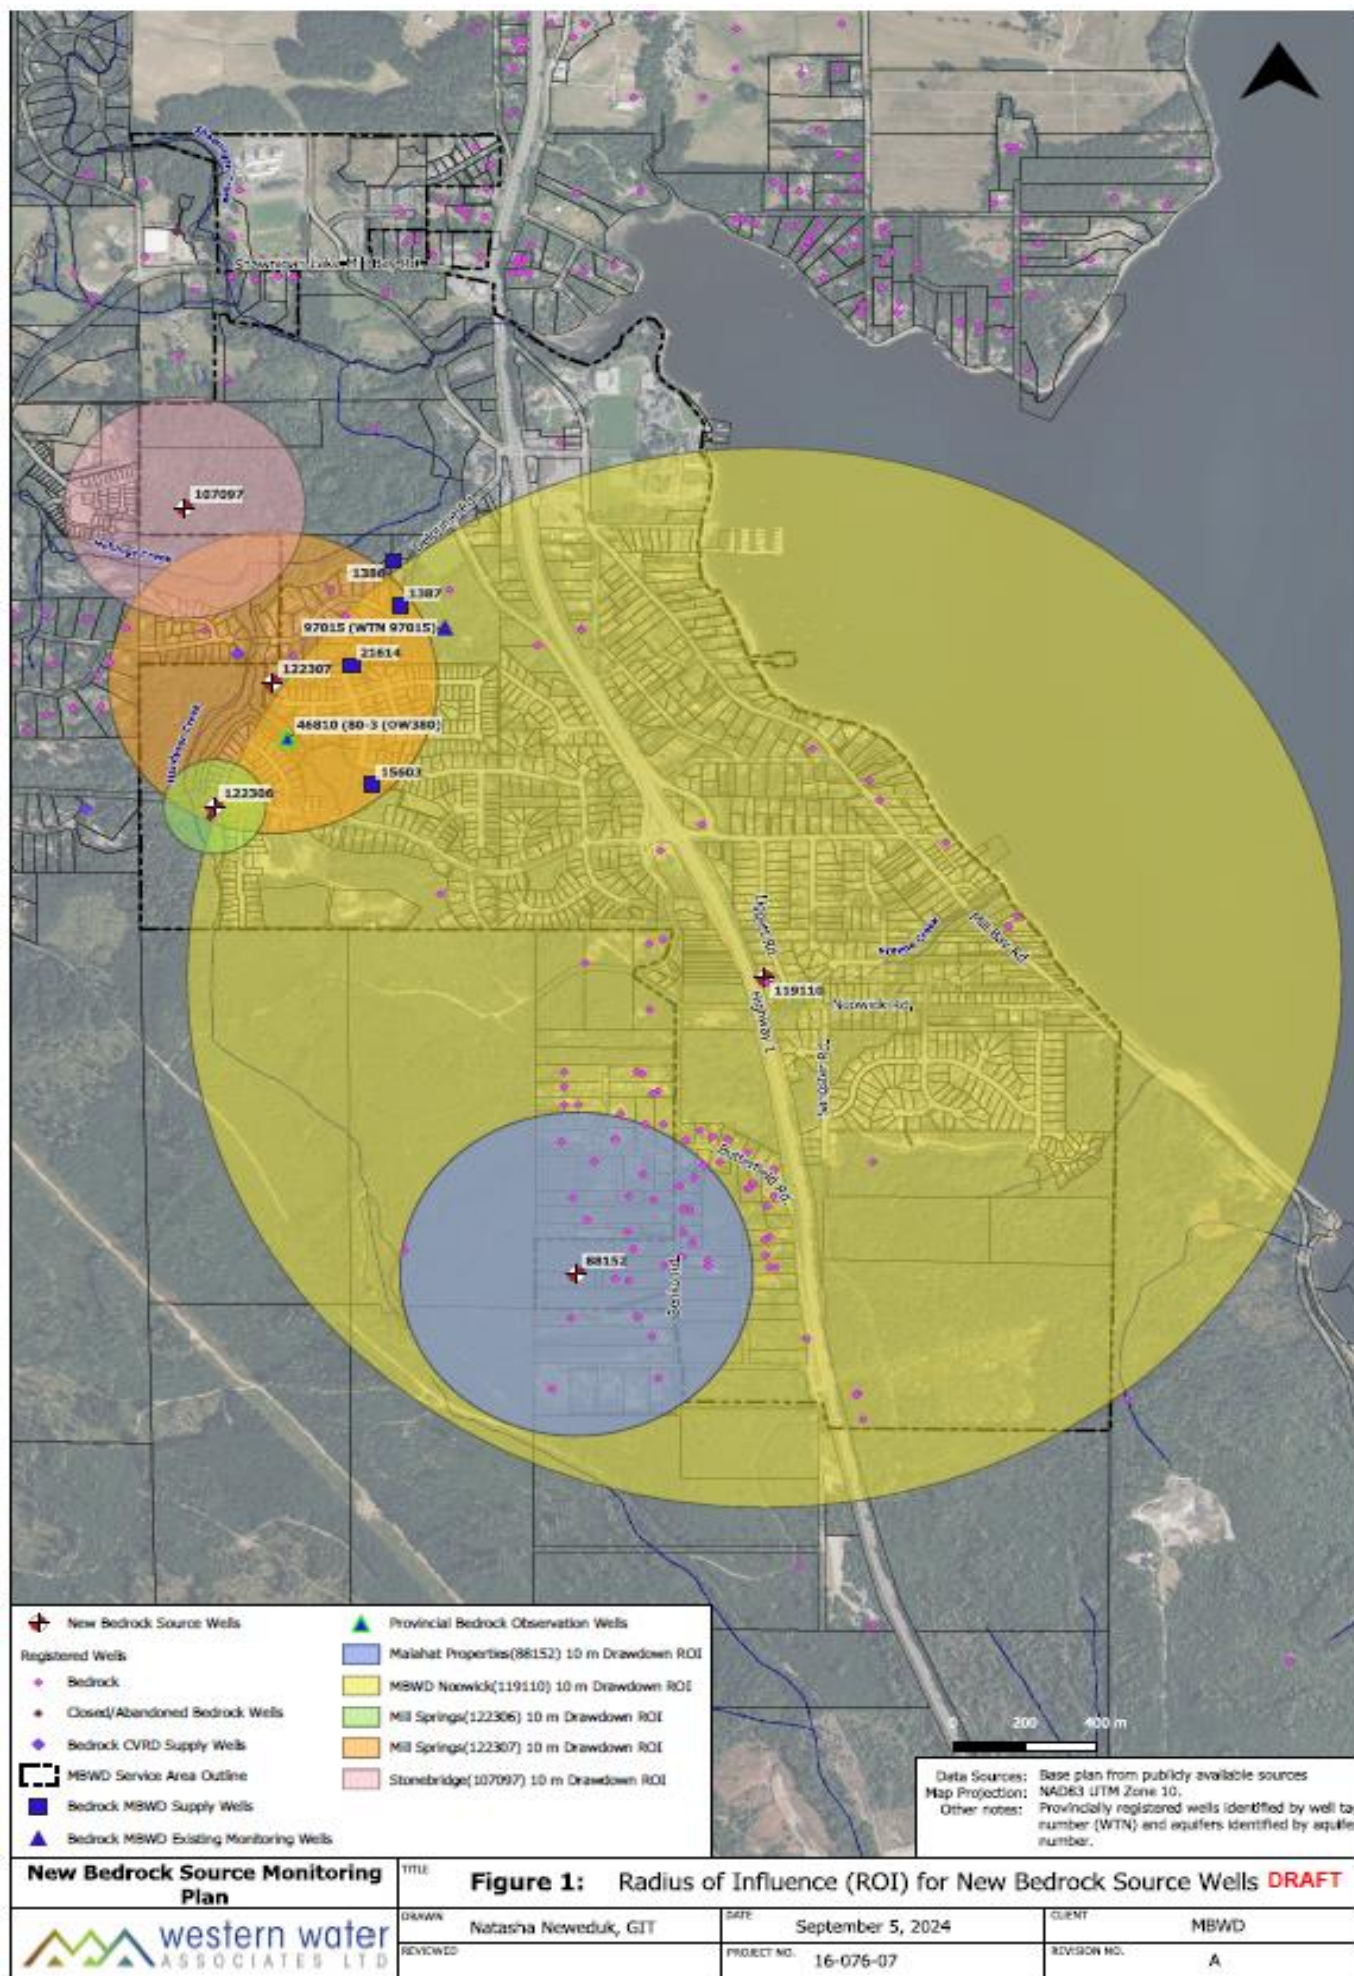
Figure (1), below illustrates the location of the proposed development Wells and the MBWD Noowick Well.

MBWD is currently working with Western Water Associates Limited (WWAL) to prepare for Well pump testing of the new system Wells which have recently received conditional licenses for the Limona Stonebridge development, Malahat Property development, the Mill Springs Development, and the MBWD Noowick Well.
